WOODSIDE JUVENILE REHABILITATION CENTER

FEASIBILITY REPORT
DECEMBER 22, 2016

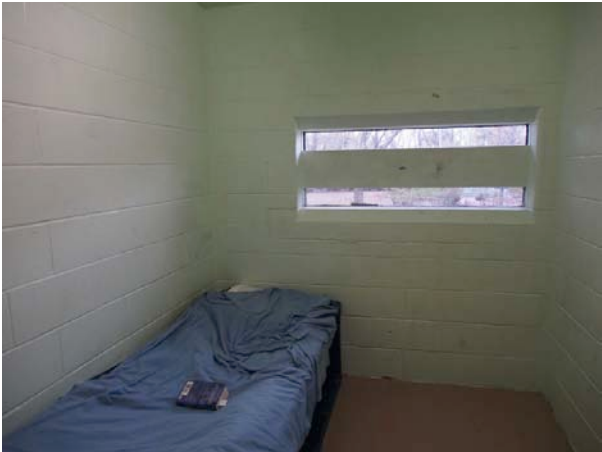
EXISTING RESIDENT SLEEPING ROOM

- Resident rooms feel like jail cells.
- Resident room doors swing in instead of out hindering access and safety. This is dangerous for both staff and youth if the staff needs to get a door open.
- Resident rooms have too many unsafe aspects including ligature points (defined as something that can be used to hang from). Rooms provide access to lighting and other elements which can be damaged or weaponized.
- Portions of common space and bathrooms also create unsafe conditions.

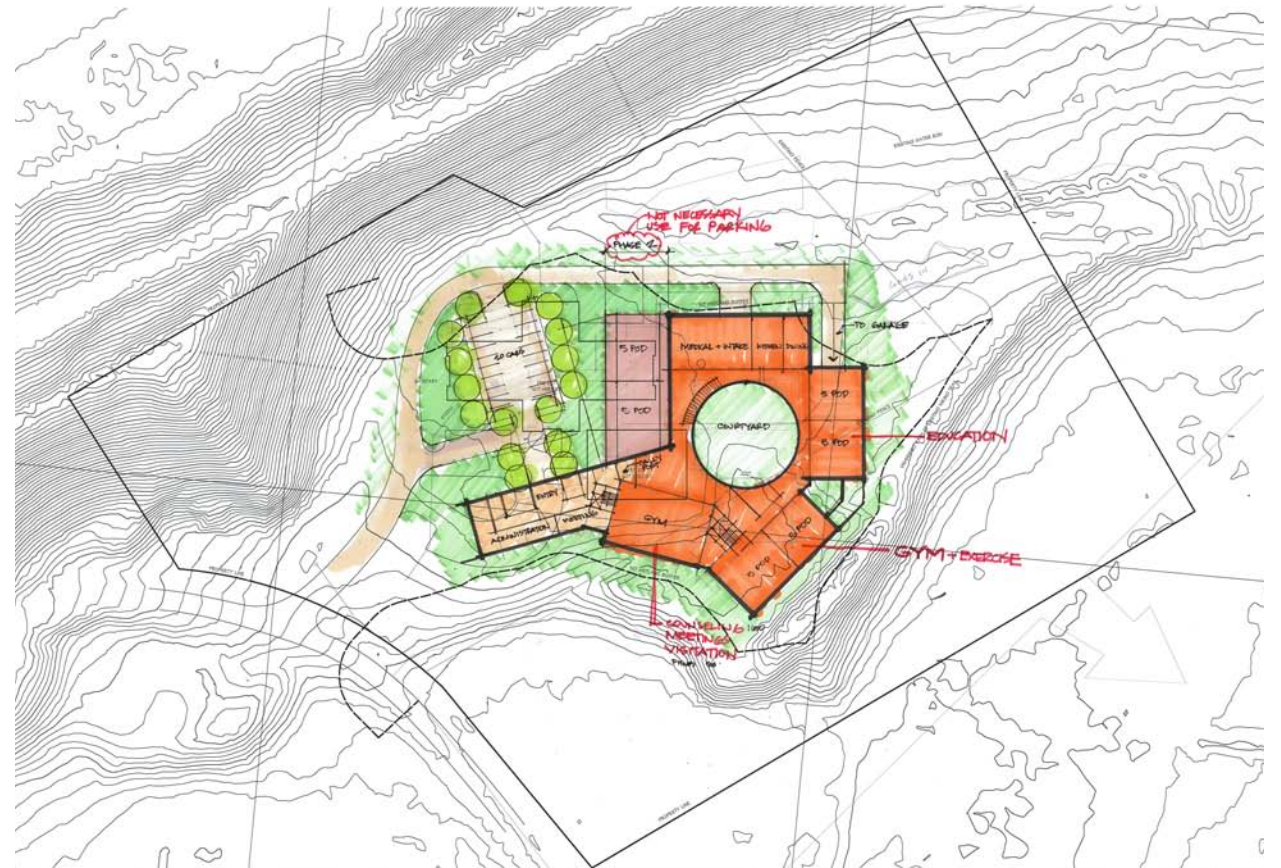
DESIGN SKETCH

- This initial sketch thought it might be necessary to include underground parking and that the existing gym would be demolished in Phase 1. As the design developed both of these ideas were abandoned. We had enough space on site to provide sufficient parking and recreational space on the surface and we found ways to keep the existing gym because it was a large program element and we could save significant money in new construction by doing this.
